# Safety Inspection Report

## Annual Inspection

<b>Site Name</b>	North Rigton Play Area	No Image
<b>Provider</b>	Harrogate Borough Council	
<b>Actual Date</b>	28/09/2021 13:39:21	
<b>Inspection Type</b>	Playground-Annual	
<b>Inspector</b>	David Owen

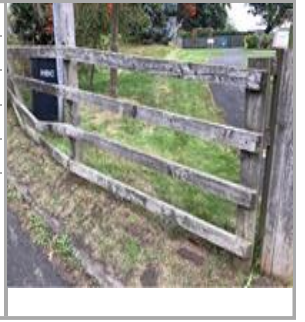
<b>Asset Name</b>	Fencing - Post & Rail - Wooden
<b>EN Compliant</b>	
<b>Manufacturer</b>	Owner/Operator
<b>Risk Score</b>	Three
<b>Risk Level</b>	Very Low

<b>Finding Notes</b>	Rails and posts decaying. Replace affected parts.	
<b>Finding Title</b>	Timber - Decay	
<b>Location</b>		
<b>Risk Level</b>	Low	
<b>Risk Score</b>	Seven	
<b>Standard Description</b>	Timber decay

<b>Task Title</b>	Replace item
<b>Task Notes</b>

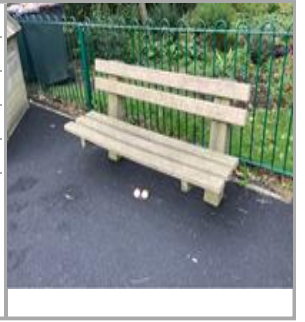
<b>Asset Name</b>	Seating - Benches x 3
<b>EN Compliant</b>	
<b>Manufacturer</b>	Owner/Operator
<b>Risk Score</b>	Three
<b>Risk Level</b>	Very Low

<b>Asset</b>	Seating - Benches x 3
<b>Finding Notes</b>	Seat leg decayed, slat loose - replace leg.
<b>Finding Title</b>	Timber - Decay
<b>Location</b>	
<b>Risk Level</b>	Medium
<b>Risk Score</b>	Eight
<b>Standard Description</b>	Timber decay

<b>Task Title</b>	Replace item
<b>Task Notes</b>
